## Inspection Report / Inspection: 1

| Date<br><b>19.01.2010</b> | P/O. No. | Weather | Surveyor's Name<br><b>Stanley Miller</b> | Pipe Segment Reference | Section No.<br><b>8</b> |

| Street<br><b>123</b> | <b>17th Street</b> | Use of Sewer | Upstream MH<br><b>1_ST17</b> |

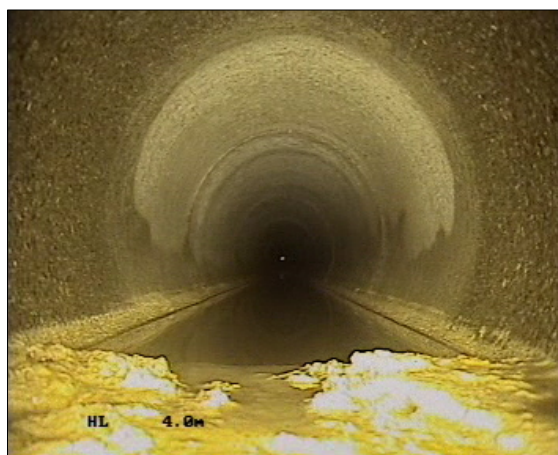
| 1:270 | Position | Code | Observation | Photo |
|---|---|---|---|---|
| | 12.00 | DSZ | Deposits Settled Other, 5 %of cross sectional area, from 05 to 07 o'clock, , within 8 inches of joint: NO | 8_3A |

Photo: 8\_3A, Media No.: 010208\_1, 00:01:26  
 12FT, Deposits Settled Other, 5 %of cross sectional area, from 05 to 07 o'clock, , within 8 inches of joint: NO

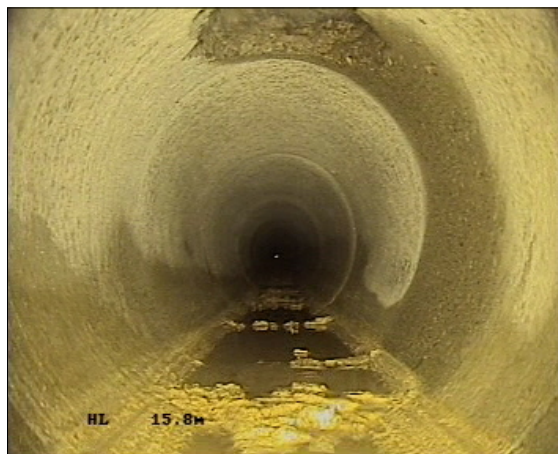
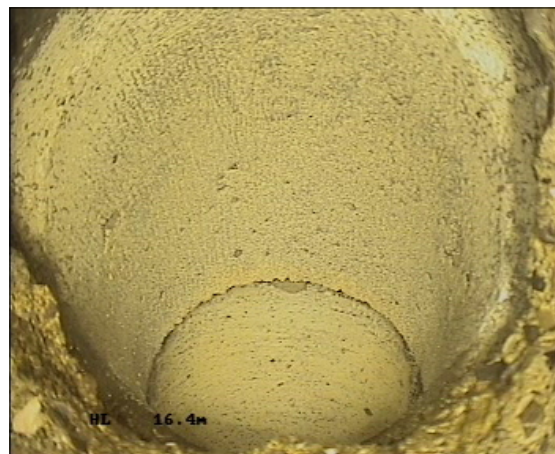
| 1:270 | Position | Code | Observation | Photo |
|---|---|---|---|---|
| | 48.00 | TBA | Tap Break-In Active, at 12 o'clock, 5", within 8 inches of joint: YES | 8_5A, b |

Photo: 8\_5A, Media No.: 010208\_1, 00:04:20  
 48FT, Tap Break-In Active, at 12 o'clock, 5", within 8 inches of joint: YES

Photo: 8\_5B, Media No.: 010208\_1, 00:04:20  
 48FT, Tap Break-In Active, at 12 o'clock, 5", within 8 inches of joint: YES

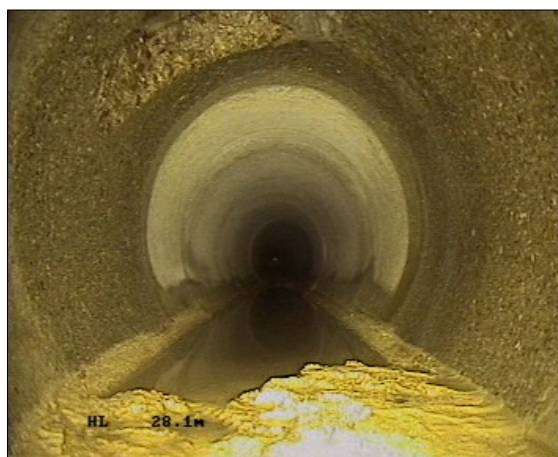
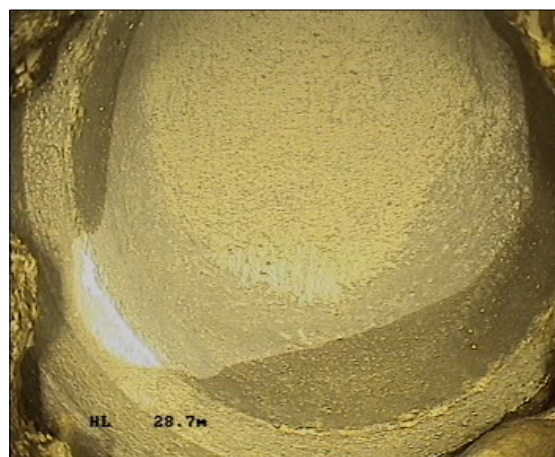
| 1:270 | Position | Code | Observation | Photo |
|---|---|---|---|---|
| | 85.50 | TBA | Tap Break-In Active, at 11 o'clock, 5", within 8 inches of joint: YES | 8_6A, b |

Photo: 8\_6A, Media No.: 010208\_1, 00:07:46  
 85.5FT, Tap Break-In Active, at 11 o'clock, 5", within 8 inches of joint: YES

Photo: 8\_6B, Media No.: 010208\_1, 00:07:46  
 85.5FT, Tap Break-In Active, at 11 o'clock, 5", within 8 inches of joint: YES

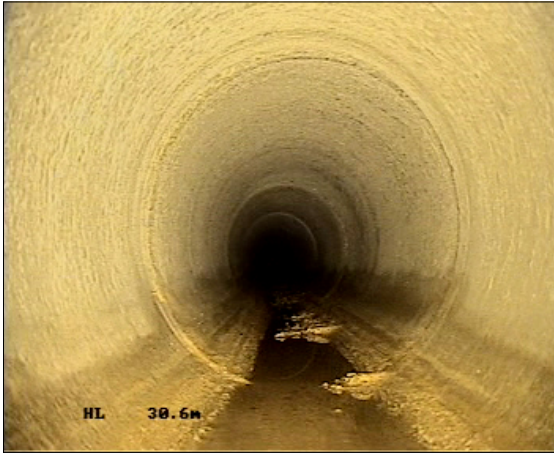
| 1:270 | Position | Code | Observation | Photo |
|---|---|---|---|---|
| | 111.90 | DSC | Deposits Settled Compacted, 5 %of cross sectional area, from 03 to 06 o'clock, , within 8 inches of joint: NO | 8_7A |

Photo: 8\_7A, Media No.: 010208\_1, 00:10:20  
 111.9FT, Deposits Settled Compacted, 5 %of cross sectional  
 area, from 03 to 06 o'clock, , within 8 inches of joint: NO

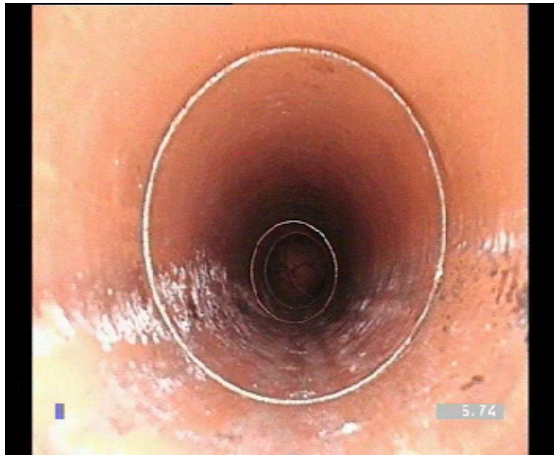
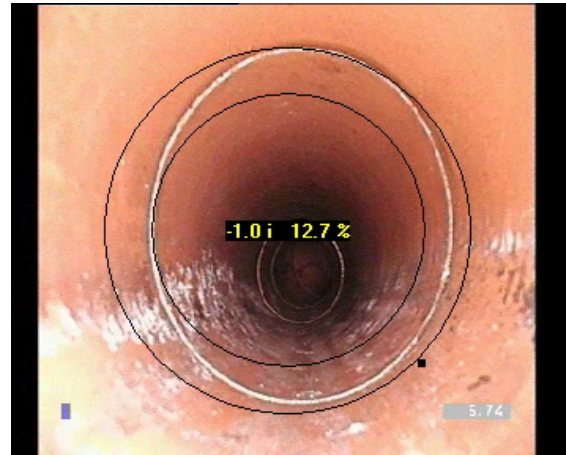
| 1:75 | Position | Code | Observation | Photo |
|---|---|---|---|---|
| | 17.00 | D | Deformed, 10 % | 4_2A, b |

Photo: 4\_2A, VCR No.: 010208\_1  
17FT, Deformed, 10 %

Photo: 4\_2B, VCR No.: 010208\_1  
17FT, Deformed, 10 %

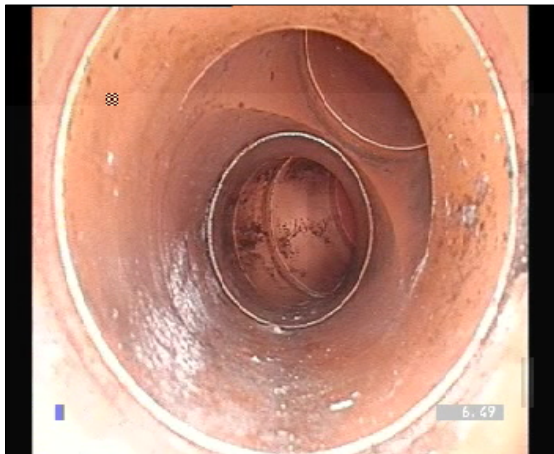
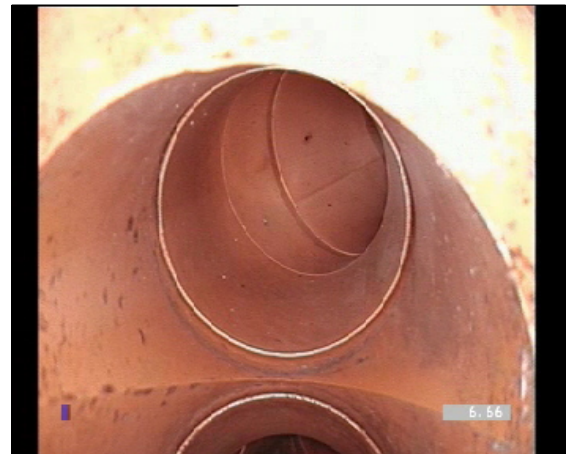
| 1:75 | Position | Code | Observation | Photo |
|---|---|---|---|---|
| | 20.00 | TS | Tap Saddle, at 02 o'clock, 5", within 8 inches of joint: NO | 4_3A, b |

Photo: 4\_3A, VCR No.: 010208\_1  
20FT, Tap Saddle, at 02 o'clock, 5", within 8 inches of joint: NO

Photo: 4\_3B, VCR No.: 010208\_1  
20FT, Tap Saddle, at 02 o'clock, 5", within 8 inches of joint: NO

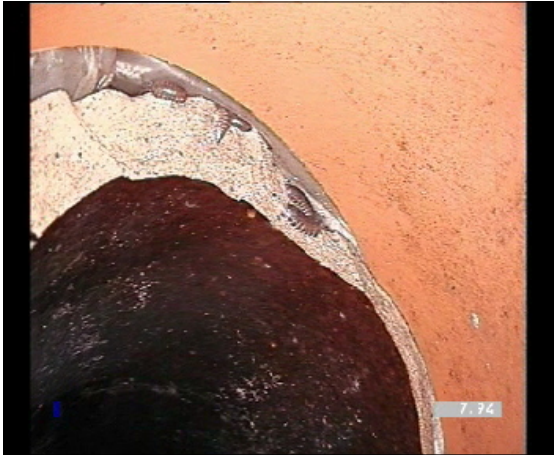
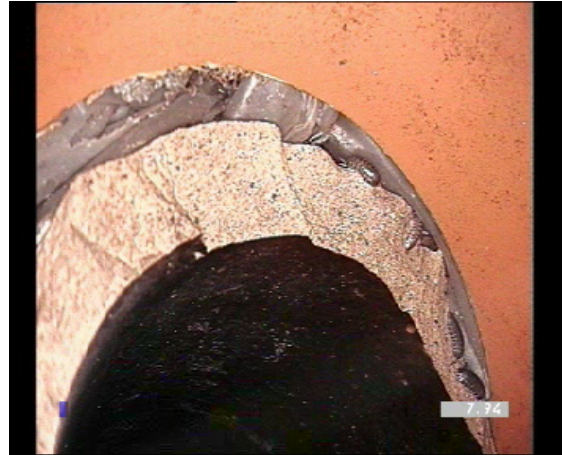
| 1:75 | Position | Code | Observation | Photo |
|---|---|---|---|---|
| | 24.00 | VZ | Vermine Other, quantity: 2 cm, within 8 inches of joint: NO / cannot be determined | 4_4A, b |

Photo: 4\_4A, VCR No.: 010208\_1  
 24FT, Vermin Other, quantity: 2 cm, within 8 inches of joint:  
 NO / cannot be determined

Photo: 4\_4B, VCR No.: 010208\_1  
 24FT, Vermin Other, quantity: 2 cm, within 8 inches of joint:  
 NO / cannot be determined

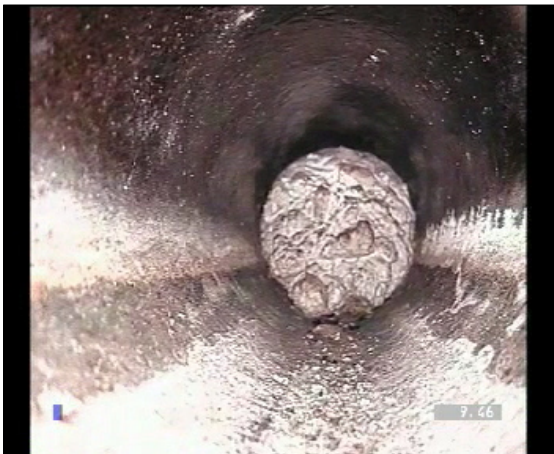
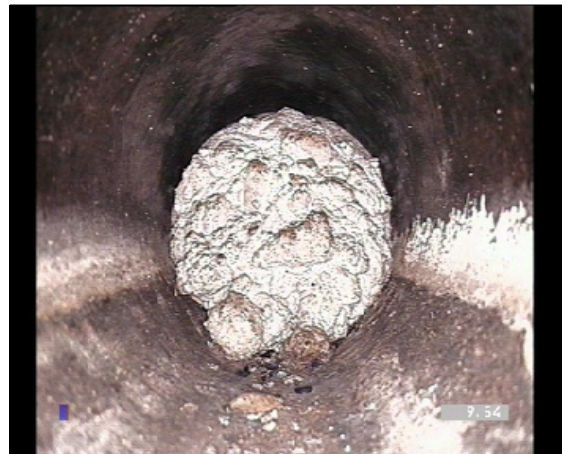
| 1:75 | Position | Code | Observation | Photo |
|---|---|---|---|---|
| | 30.00 | OBZ | Obstacles Other, 100 % of cross sectional area, from 12 to 12 o'clock | 4_6A, b |

Photo: 4\_6A, VCR No.: 010208\_1  
 30FT, Obstacles Other, 100 %of cross sectional area, from  
 12 to 12 o'clock

Photo: 4\_6B, VCR No.: 010208\_1  
 30FT, Obstacles Other, 100 %of cross sectional area, from  
 12 to 12 o'clock

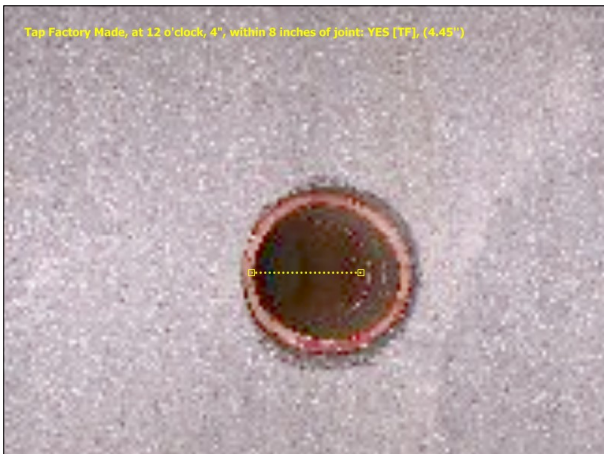
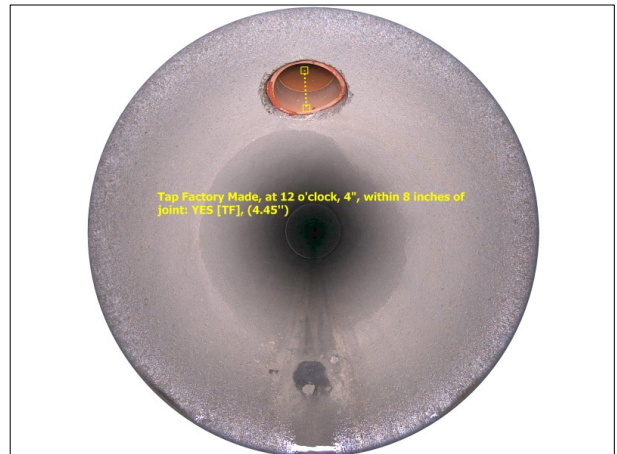
Photo: 7\_2A, Media No.: 010208\_1  
 29.73FT, Tap Factory Made, at 12 o'clock, 4", within 8 inches of joint: YES

Photo: 7\_2B, Media No.: 010208\_1  
 29.73FT, Tap Factory Made, at 12 o'clock, 4", within 8 inches of joint: YES

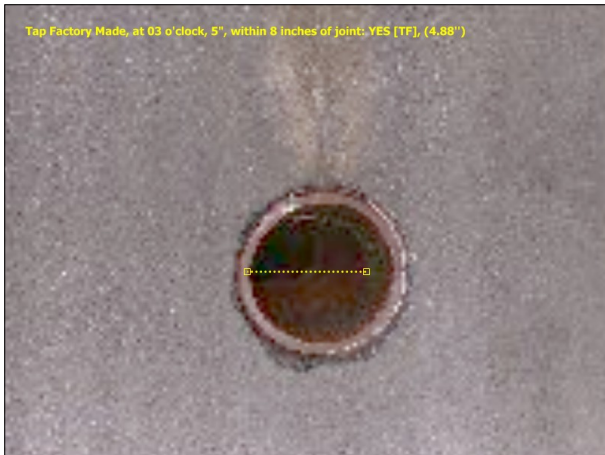
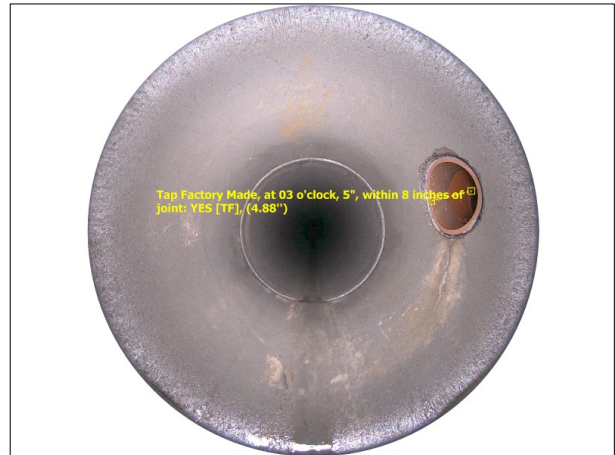
Photo: 7\_3A, Media No.: 010208\_1  
 90.59FT, Tap Factory Made, at 03 o'clock, 5", within 8 inches of joint: YES

Photo: 7\_3B, Media No.: 010208\_1  
 90.59FT, Tap Factory Made, at 03 o'clock, 5", within 8 inches of joint: YES

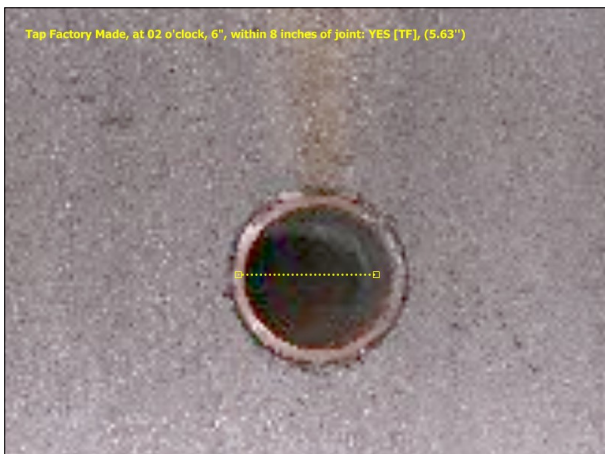
Photo: 7\_4A, Media No.: 010208\_1  
 105.97FT, Tap Factory Made, at 02 o'clock, 6", within 8 inches of joint: YES

Photo: 7\_4B, Media No.: 010208\_1  
 105.97FT, Tap Factory Made, at 02 o'clock, 6", within 8 inches of joint: YES

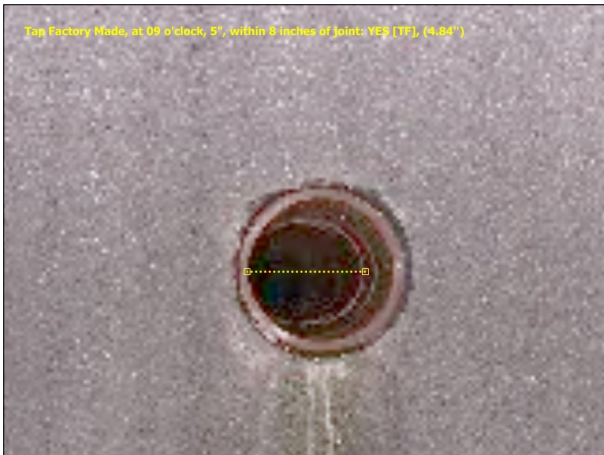
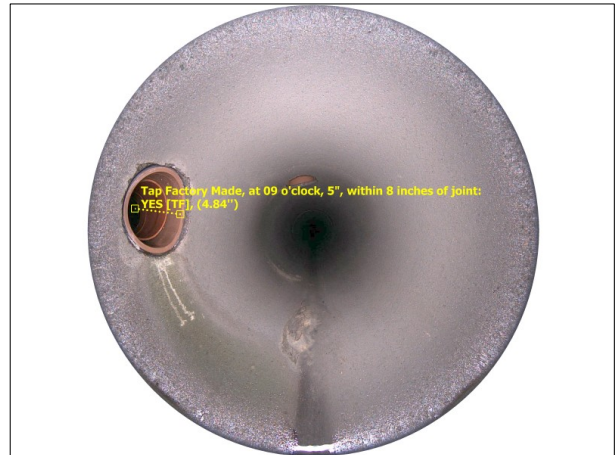
Photo: 7\_5A, Media No.: 010208\_1  
 134.91FT, Tap Factory Made, at 09 o'clock, 5", within 8 inches of joint: YES

Photo: 7\_5B, Media No.: 010208\_1  
 134.91FT, Tap Factory Made, at 09 o'clock, 5", within 8 inches of joint: YES

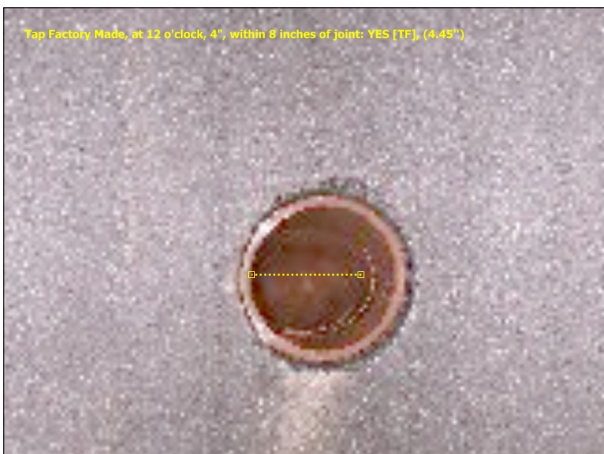
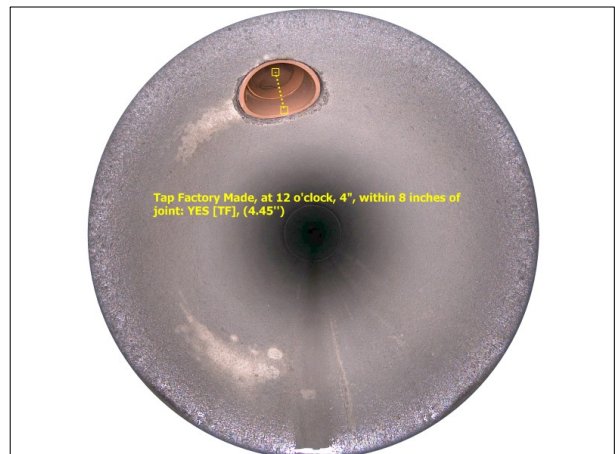
Photo: 7\_6A, Media No.: 010208\_1  
 136.98FT, Tap Factory Made, at 12 o'clock, 4", within 8 inches of joint: YES

Photo: 7\_6B, Media No.: 010208\_1  
 136.98FT, Tap Factory Made, at 12 o'clock, 4", within 8 inches of joint: YES

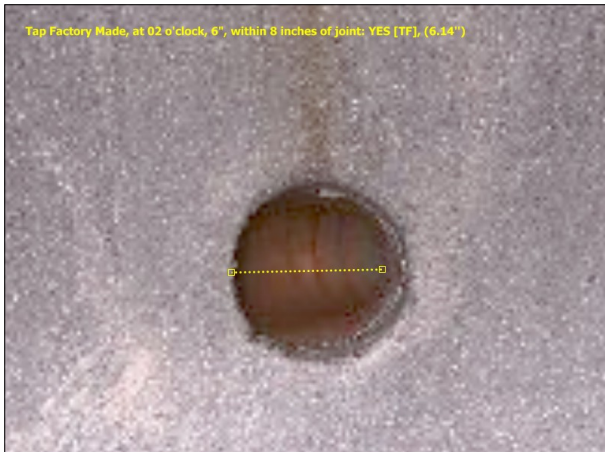
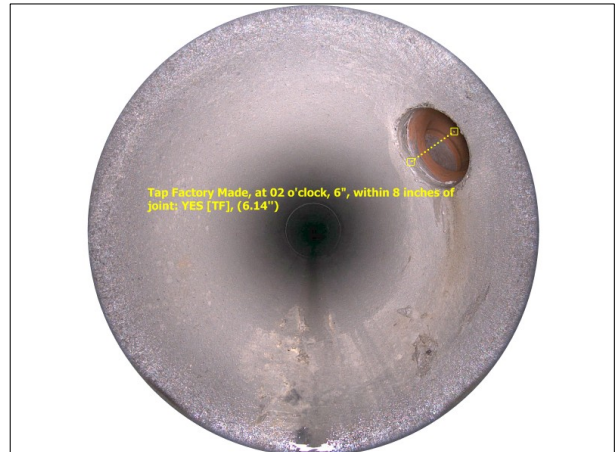
Photo: 7\_7A, Media No.: 010208\_1  
 177.99FT, Tap Factory Made, at 02 o'clock, 6", within 8 inches of joint: YES

Photo: 7\_7B, Media No.: 010208\_1  
 177.99FT, Tap Factory Made, at 02 o'clock, 6", within 8 inches of joint: YES

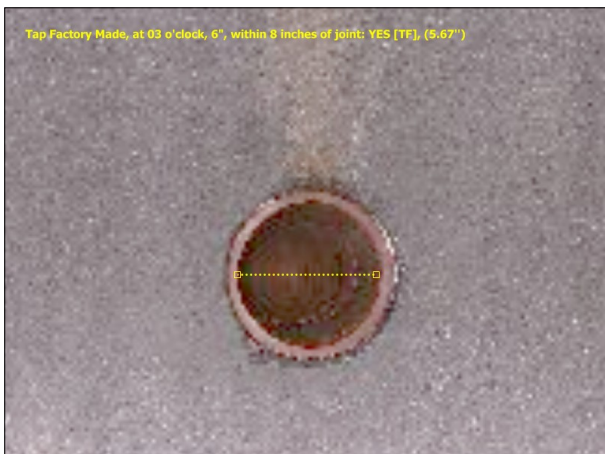
Photo: 7\_8A, Media No.: 010208\_1  
 186.42FT, Tap Factory Made, at 03 o'clock, 6", within 8 inches of joint: YES

Photo: 7\_8B, Media No.: 010208\_1  
 186.42FT, Tap Factory Made, at 03 o'clock, 6", within 8 inches of joint: YES

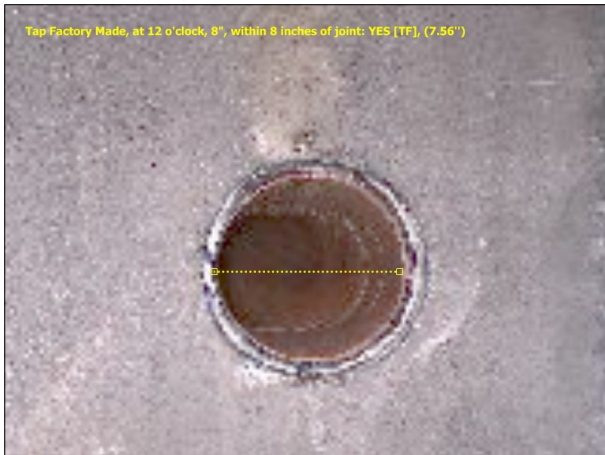
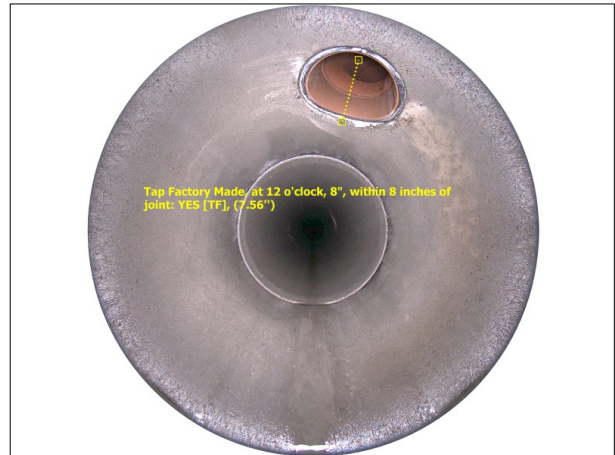
Photo: 7\_9A, Media No.: 010208\_1  
 238.89FT, Tap Factory Made, at 12 o'clock, 8", within 8 inches of joint: YES

Photo: 7\_9B, Media No.: 010208\_1  
 238.89FT, Tap Factory Made, at 12 o'clock, 8", within 8 inches of joint: YES

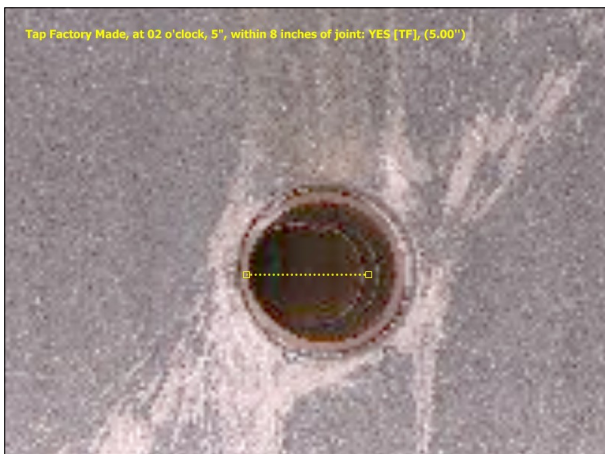
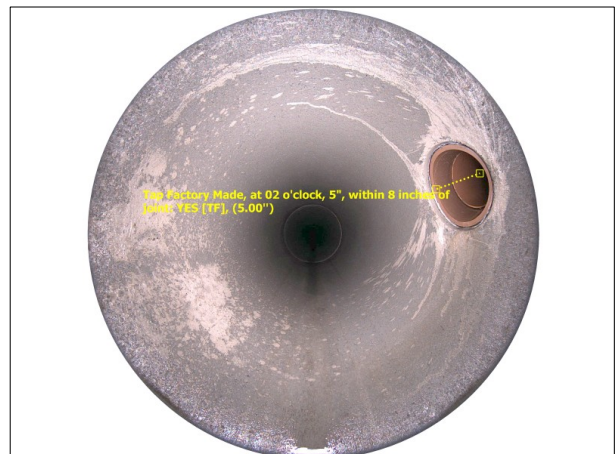
Photo: 7\_10A, Media No.: 010208\_1  
 244.04FT, Tap Factory Made, at 02 o'clock, 5", within 8 inches of joint: YES

Photo: 7\_10B, Media No.: 010208\_1  
 244.04FT, Tap Factory Made, at 02 o'clock, 5", within 8 inches of joint: YES

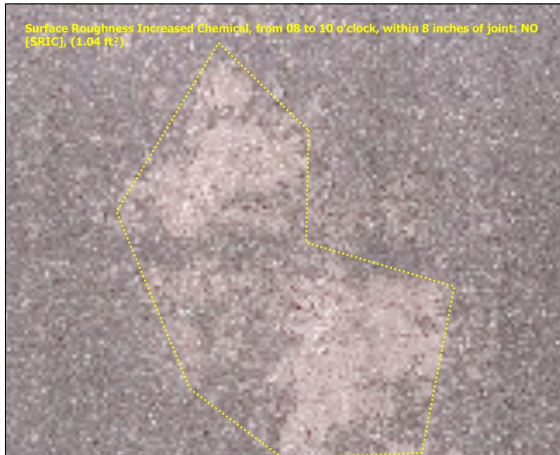
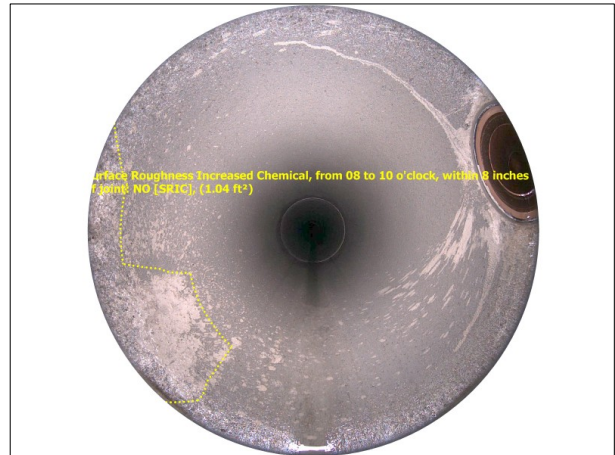
| 1:645 | Position | Code | Observation | Photo | | | |
|---|---|---|---|---|---|---|---|
| | 244.14 | SRIC | Surface Roughness Increased Chemical, from 08 to 10 o'clock, within 8 inches of joint: NO | 7_11A, b | | | |

Photo: 7\_11A, Media No.: 010208\_1  
 244.14FT, Surface Roughness Increased Chemical, from 08 to 10 o'clock, within 8 inches of joint: NO

Photo: 7\_11B, Media No.: 010208\_1  
 244.14FT, Surface Roughness Increased Chemical, from 08 to 10 o'clock, within 8 inches of joint: NO
